Aircraft Full-Scale Test Program for the 1998/99 Winter

Michael Chaput,
Medhat Hanna,
Elio Ruggi and
Jeff Mayhew

October 1999

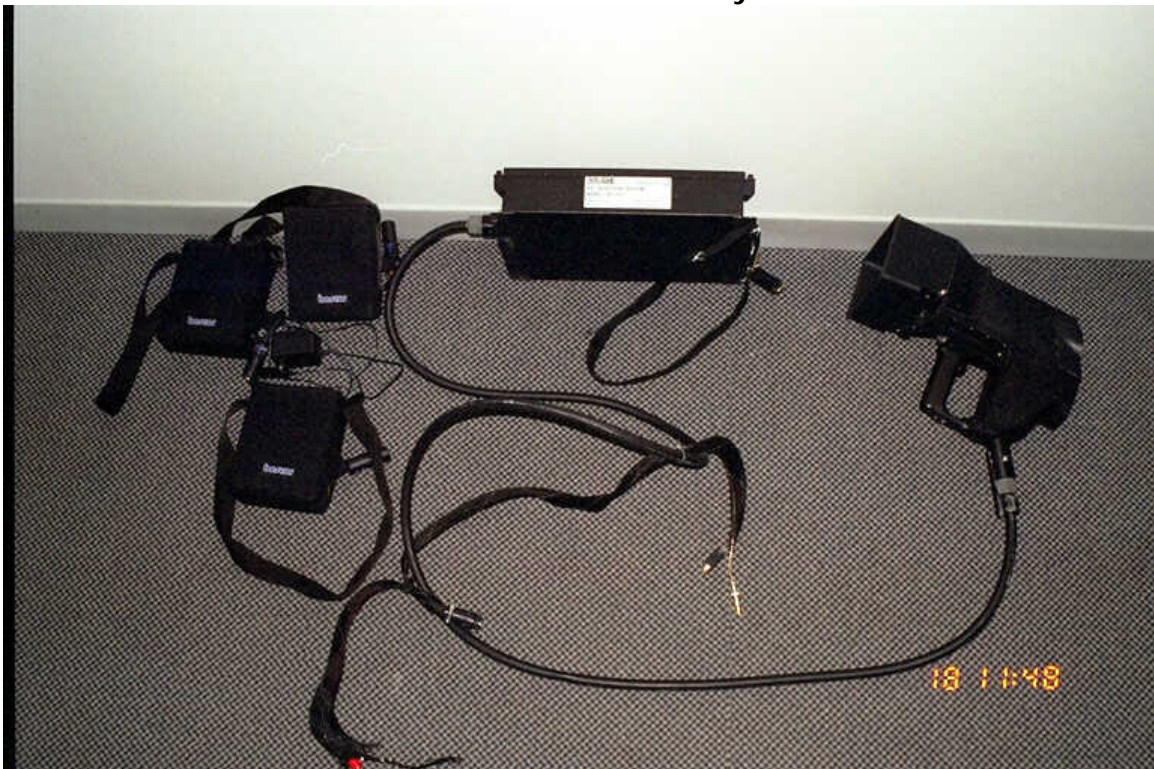
Photo 2.6
Hand-Held Ice Detection Sensor by RVSI ID-1H

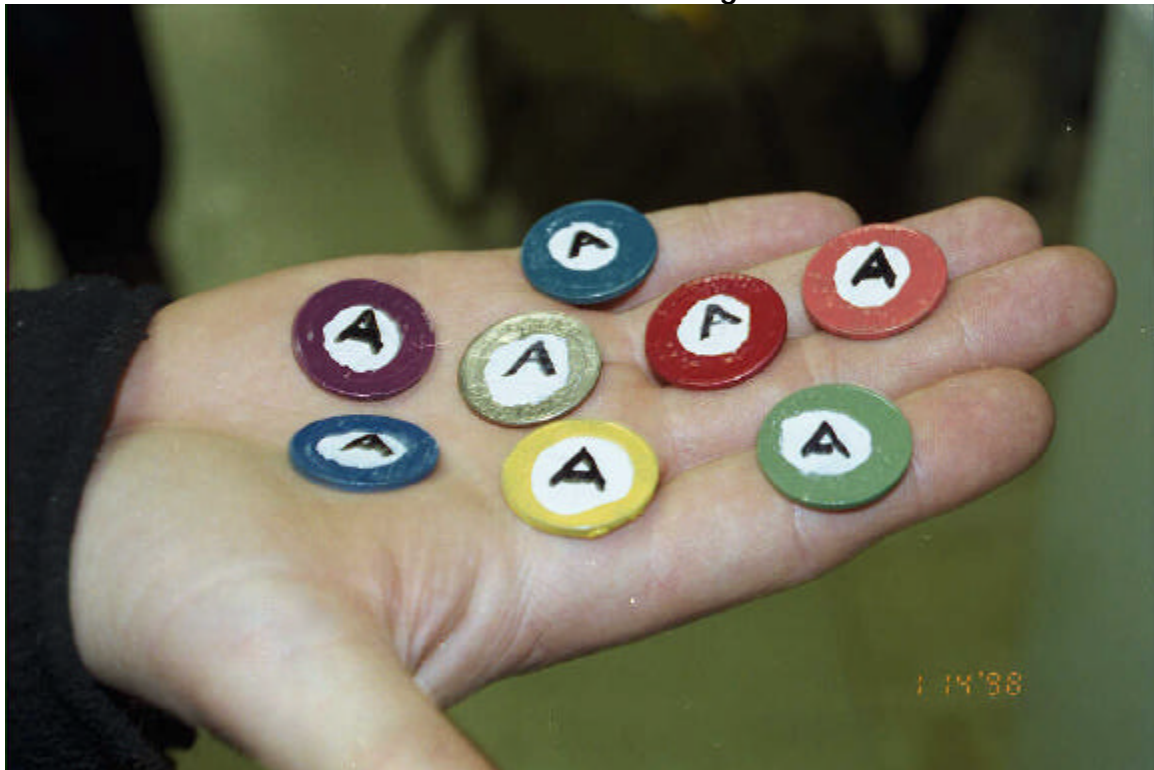
Photo 2.8
Painted Coins Used in Documentation of Roughness of Frost Formation

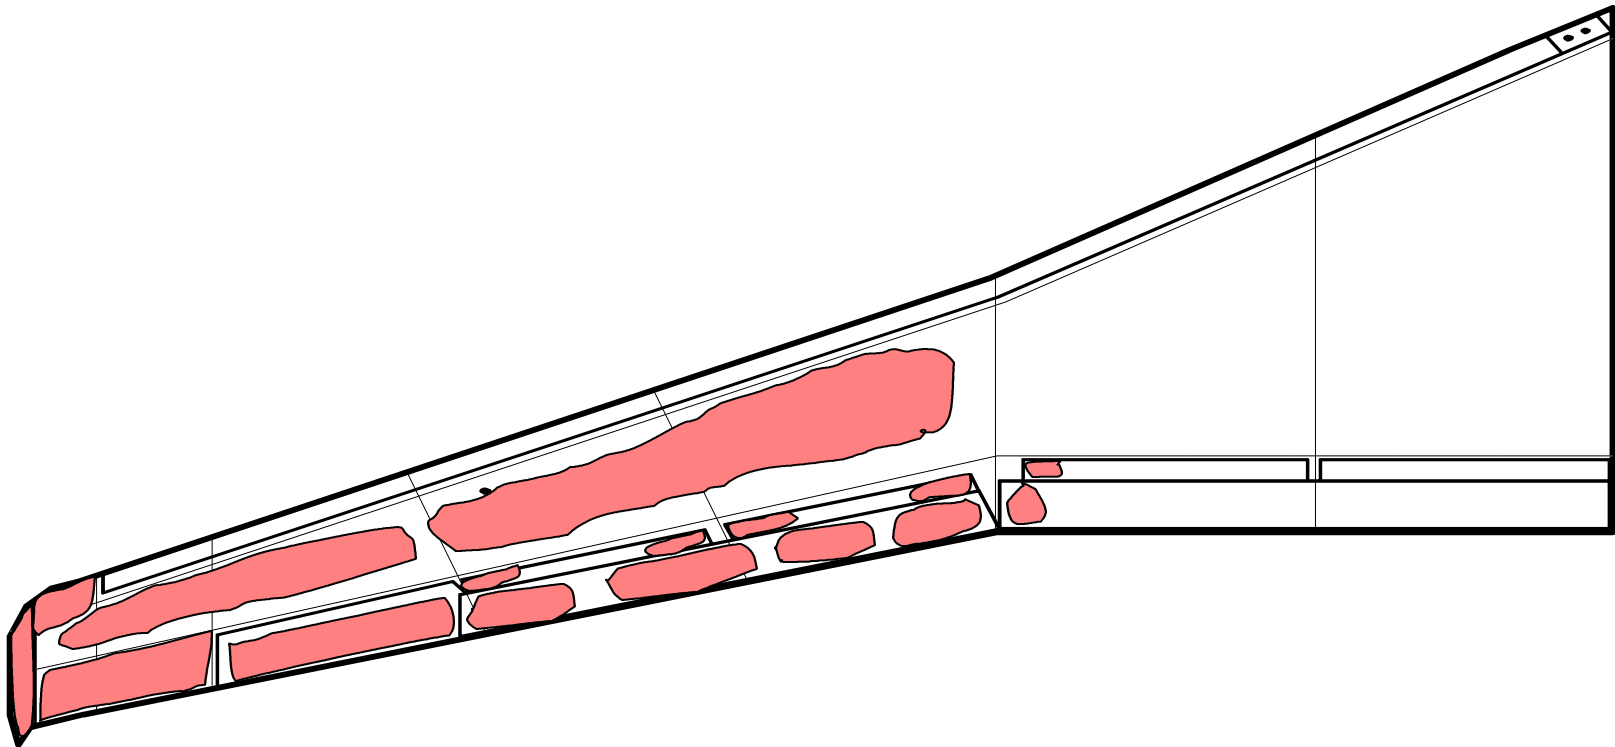
FIGURE 4.5
FROST PATTERN ON CL-65 PORT WING (ID # 3)

Another overnighting aircraft was selected by APS personnel for test purposes on February 15, 1999. The frost development patterns observed during this test (ID#3) are shown in Figure 4.5. A much lighter frost had formed on the wing surface than those observed in the two previous frost tests. Although lighter in deposition, the patterns of development were similar to the previous tests, with the heaviest accumulation on the trailing edge outboard of the aileron (see Photo 4.8). No frost was detected on the leading edge (see Photo 4.9) or on the inboard mid-wing section.

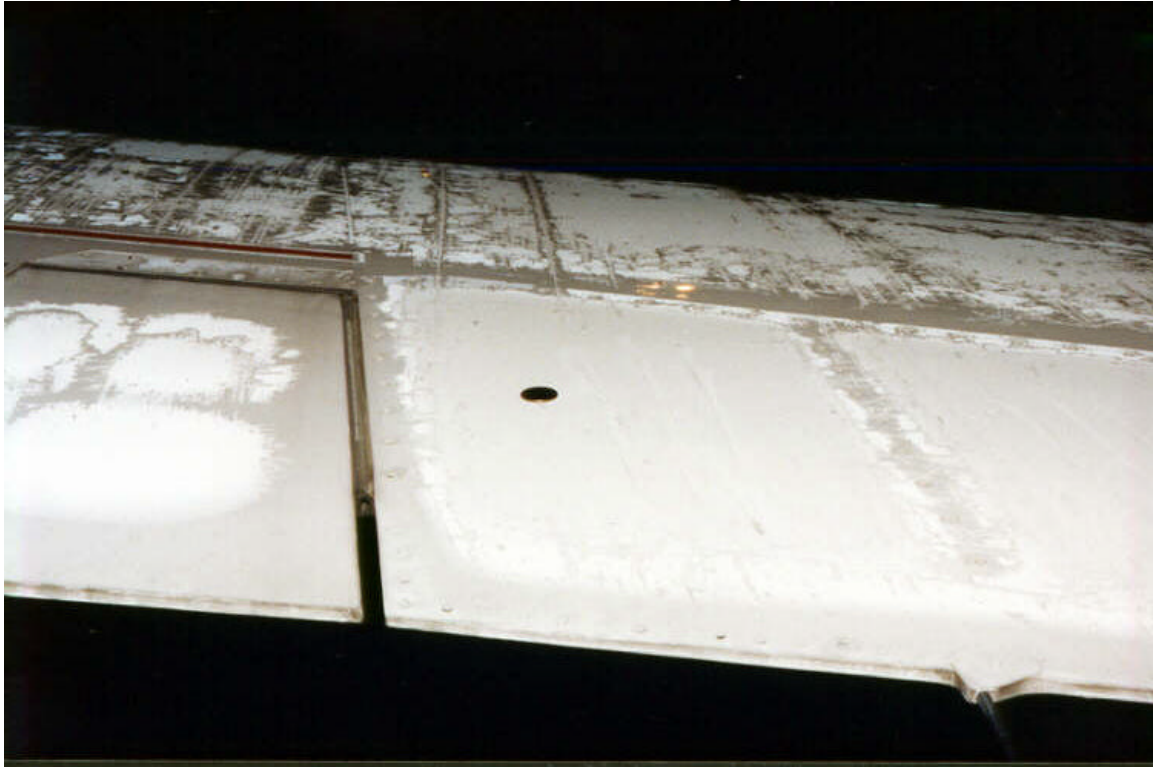
Photo 4.3

Heavy Frost Accumulation on the Aileron and Trailing Edge Outboard of the Aileron of the Starboard Wing (ID# 1)

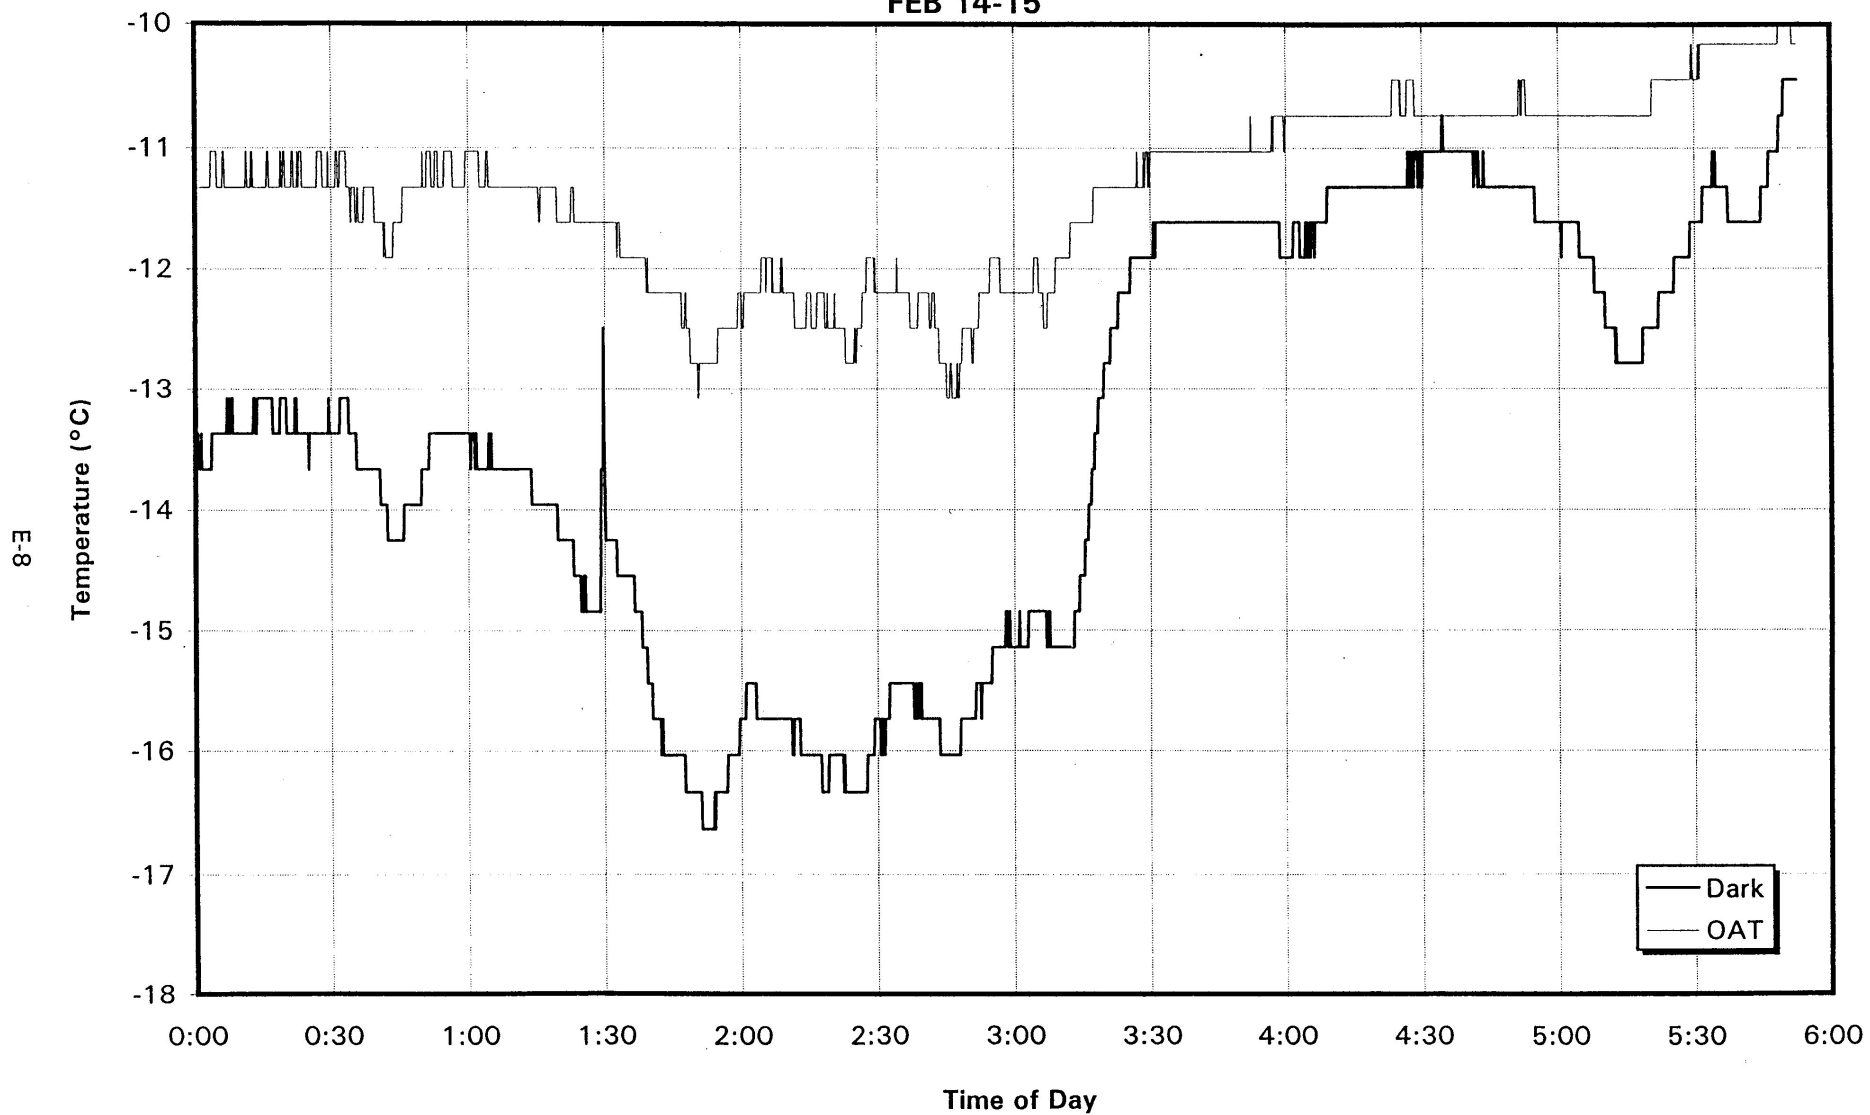
FIGURE 3.2

Unlighted Plate Surface Temperature vs OAT

FEB 14-15
